# Not All Insulation is the Same...

Fire Test Certification  
& Real Fire Case Studies

Introducing our new hybrid insulation  
core for superior fire protection

# Introducing QuadCore™ Technology

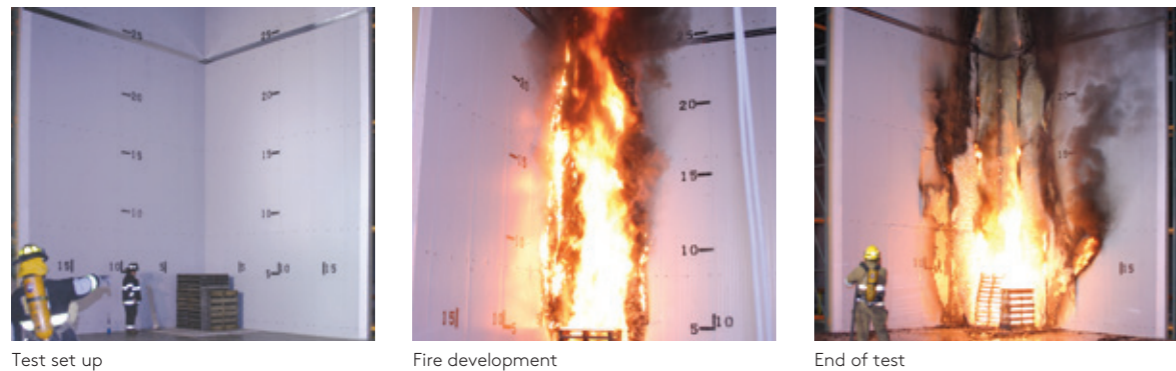
**FM 4880 / FM 4881.** The 50ft corner test shown below forms part of assessment requirements for approval to Class 1 Internal wall and ceiling panels with no height restriction (FM 4880) and external walls with no height restriction (FM 4881).

Test set up      Fire development      End of test

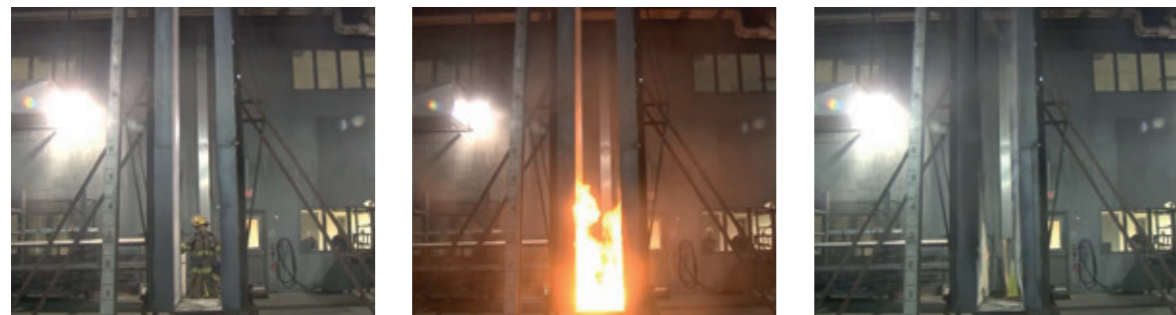
**FM 4882.** The FM parallel panel test shown below is used to measure smoke emissions from the panels and delivers certification for smoke sensitive occupancies. QuadCore™ panel systems can achieve 'Class 1 interior wall and ceiling panels' and help deliver certification for pharmaceutical, manufacturing, food preparation and storage areas or similar occupancies.

Test set up      Fire development      End of test

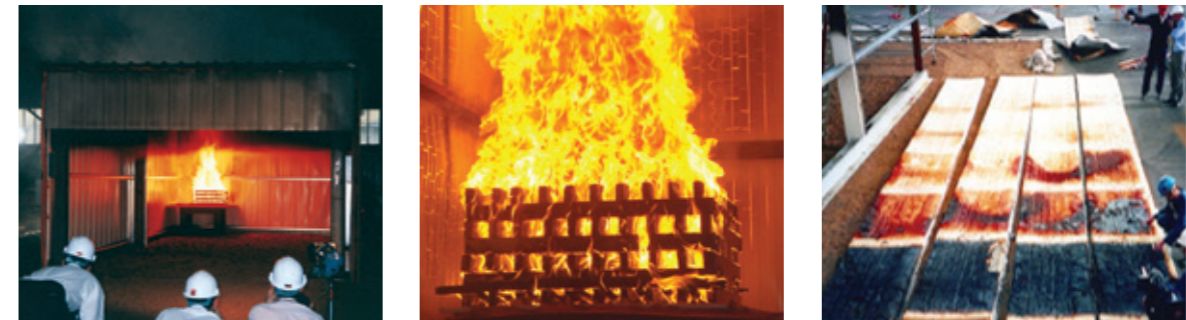
**LPS 1181: Part 1.** The test shown below forms part of the assessment requirements for EXT-B and EXT-A approval.

Test set up      During test      Inspection of protective char formation after test

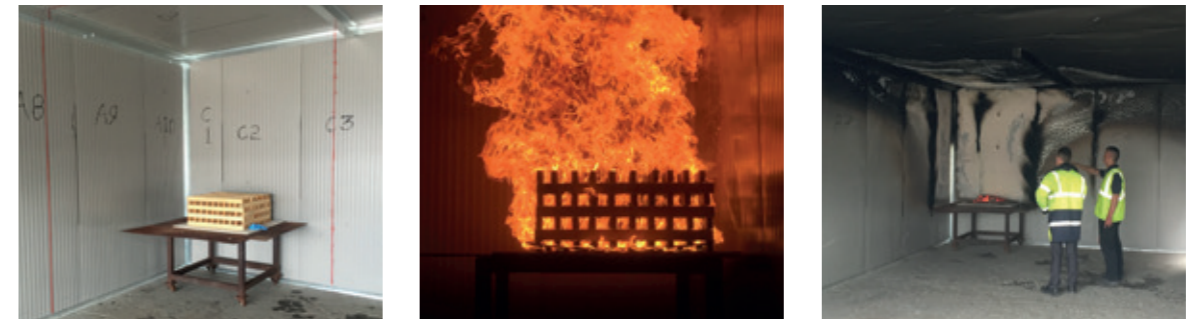
**LPS 1181: Part 2.** The test shown below forms part of the assessment requirements for INT-1 and INT-2 approval for internal applications.

Test set up      During test      Inspection of protective char formation after test

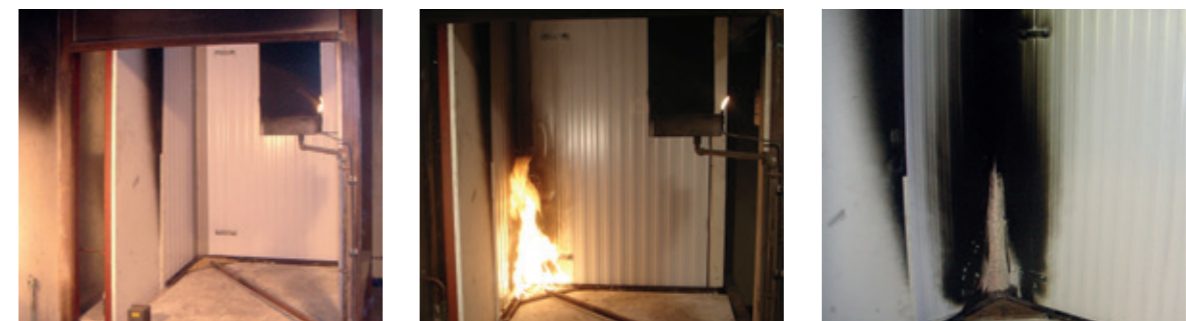
**EN 13823 SBI (Single Burning Item) Fire Test.** B-s1,d0 can be achieved to EN 13501-1.

Test set up      During test      End of test showing minimal panel damage

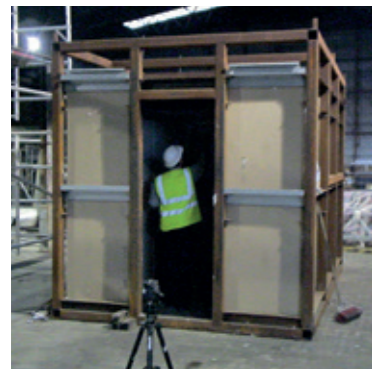
### UBC 26-3. Room test.

Test enclosure

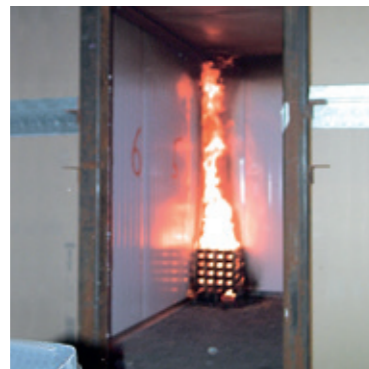
Wooden crib fire

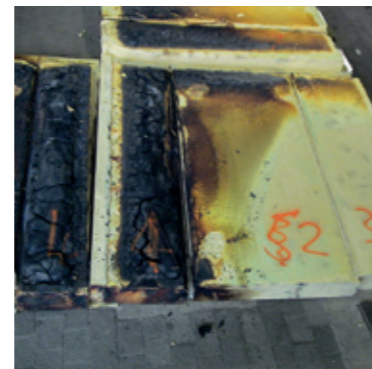
Panels at end of test with metal facings removed showing protective char formation on surface of insulation

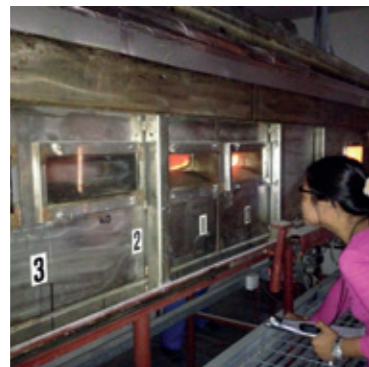
Monitoring for fire spread during test

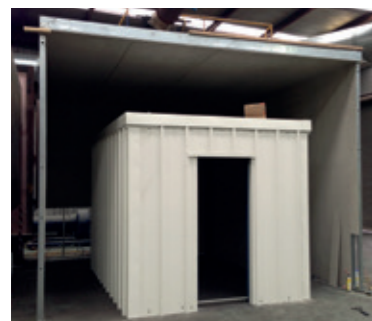
### ISO 13784 Part 1. Small room test for sandwich panels.

Test room

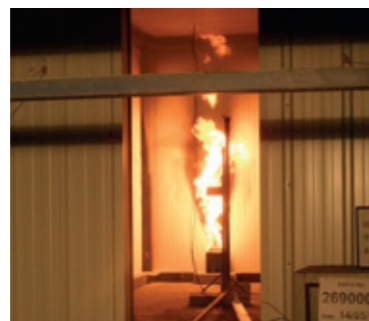
Test in progress - note burner adjacent to vertical panel joints

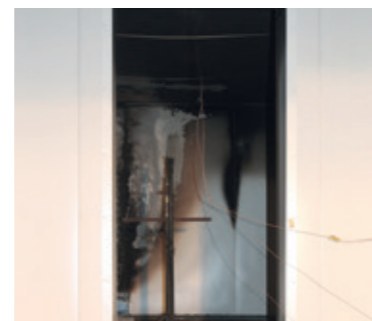
End of test showing limited internal damage and no evidence of flash-over conditions

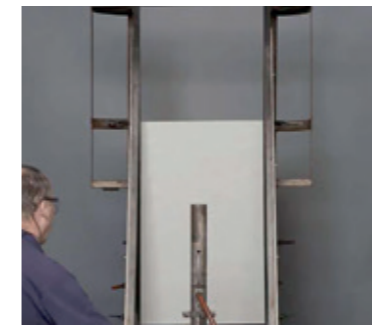
### ISO 11925 Part 3. Ignitability of building products subjected to direct impingement of flame, Part 3: Multi-source test. Test using roofer's torch.

Test set up

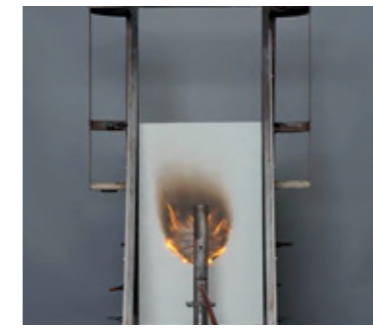
3 minute test in progress - note lack of surface burning and smoke emissions

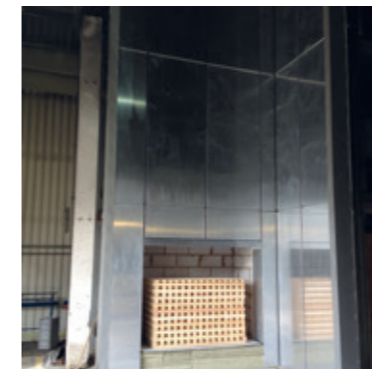
### BS 8414-2. Fire performance of external cladding systems. Requirements of BR 135 for façades over 18m high can be achieved.

Test set up - Kingspan BENCHMARK façade panels with aluminium hook on cassette

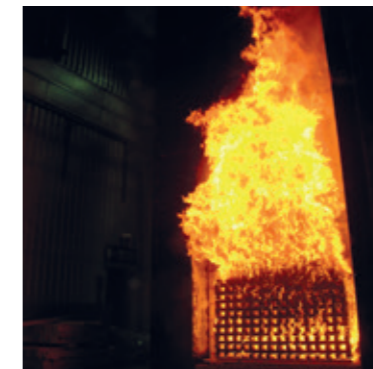
Fire load

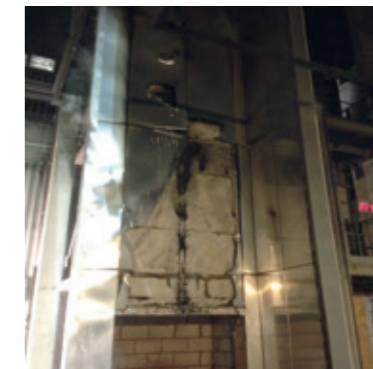
End of test showing aluminium cassette melted away to expose underlying Kingspan BENCHMARK Karrier panel in place

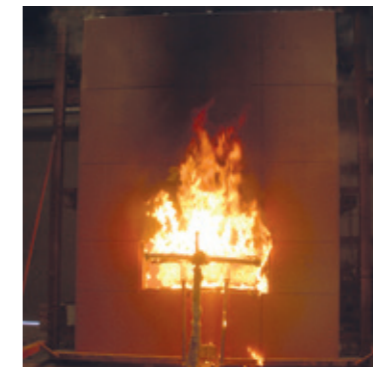
Fire exposure during test

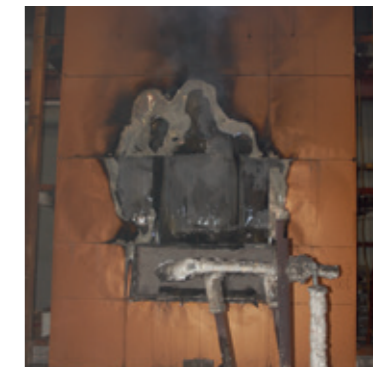
End of test demonstrating damage to ACM rainscreen with Kingspan insulated metal panels remaining intact

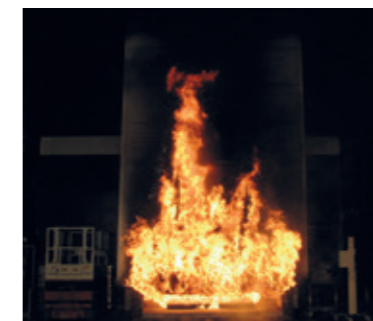
Façade during test

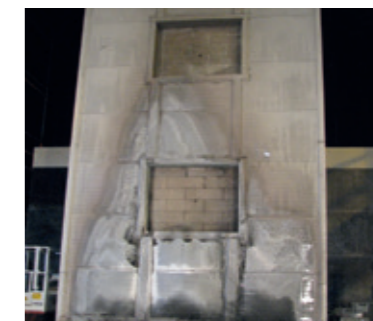
Façade after test demonstrating minimal fire spread attributable to the cladding

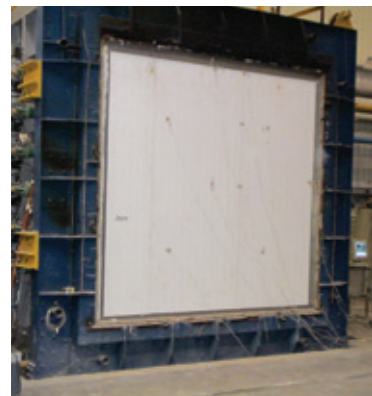
Fire resistance tests to EN 1364 (also applicable to LPS 1208). Up to EI60 on vertical walls and ceilings / roofs panel systems.

Vertical walls (3m x 3m furnace)

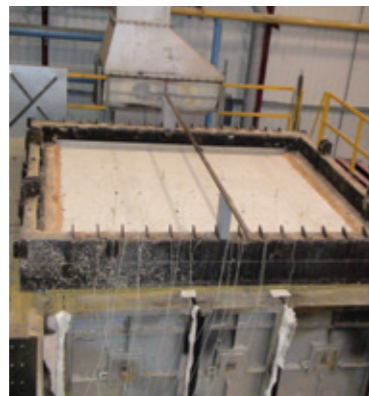
Ceilings / roofs (4m x 3m furnace)

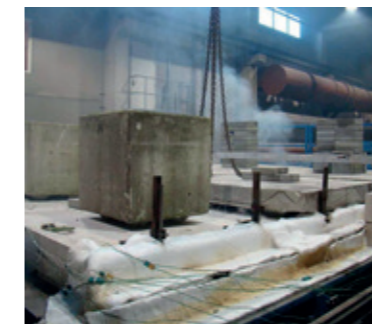
EN 1365 Part 2. Fire resistance tests for loadbearing elements. Floors and roofs.

Op-Deck after 1 hour demonstrating no failure of insulation, integrity and load bearing capacity.

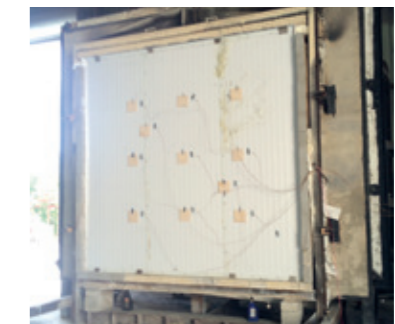
ASTM E119 Standard Test Methods for Fire Tests of Building Construction and Materials. Fire resistance test.

External face of QuadCore™ panel assembly after completion of 60 minute exposure.

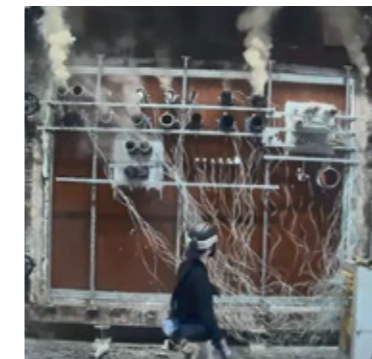
Fire resistance tests to EN 1366 Part 3 for service installations.

Test for 1 hour penetration seals.

The introduction of Kingspan's QuadCore™ Technology has enabled third party fire certification to EN 1366 Part 3 for a high performance closed-cell insulated panel fire compartment system that includes fire rated penetration seals. Addressing a well-known industry issue, this comprehensive testing takes a major step towards addressing inadequate fire safety specification in commercial and industrial buildings. It paves the way for safer, more reliable system fire performance through more robust specifications.

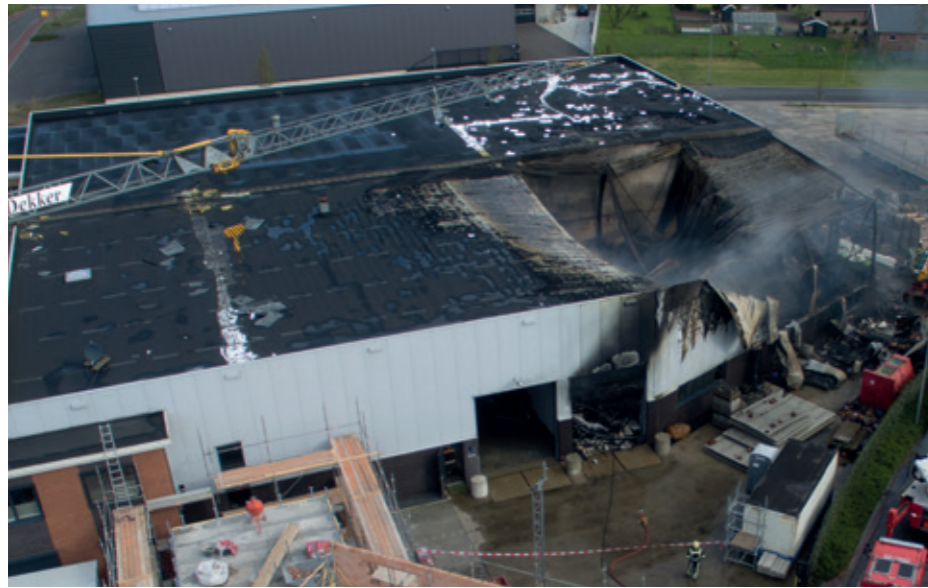
Aerial view of the damage showing structural collapse of the army surplus warehouse.

The architectural wall panels that form the upper part of the external walls of the building are LPCB and FM Approved 80mm thick KS1000 AWP wall panels with ECOsafe PIR insulation cores. The roof was constructed of a metal deck, polystyrene insulation and a bituminous membrane.

The fire in the army surplus store was extremely intense and lasted for over 4 hours. This was due, in part, to the storage of significant amounts of combustible materials in the building and the reported presence in appreciable quantities of accelerants such as cigarette lighter fluid and aerosol paint spray cans.

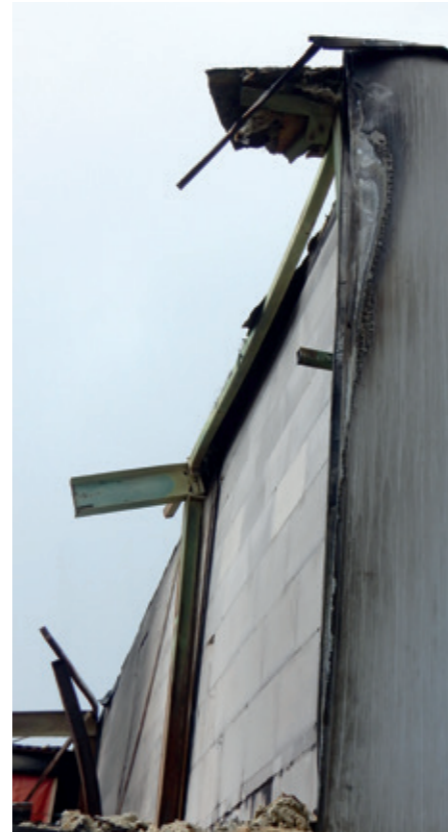
Panel at junction with internal compartment wall.

- The omission of a band of non-combustible material at the points of intersection with the compartment wall did not result in a break-down of fire compartmentation.

- The findings provide evidence that the PIR core of Kingspan LPCB and FM approved KS1000 AWP panels can provide sufficient resistance to fire propagation and erosion such that they meet the intent of reported local regulations where KS1000 AWP panels bridge across fire compartment walls.

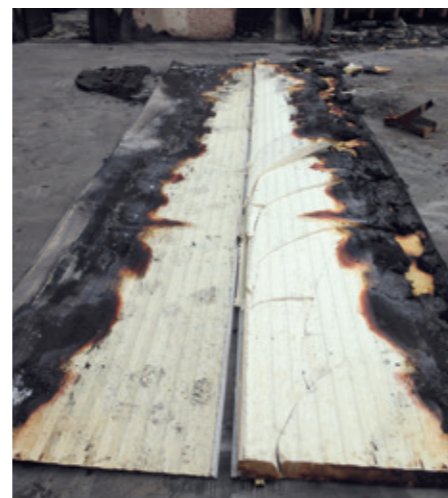
Panel at junction with steel stripped off demonstrating charring of PIR core but no evidence of fire spread.

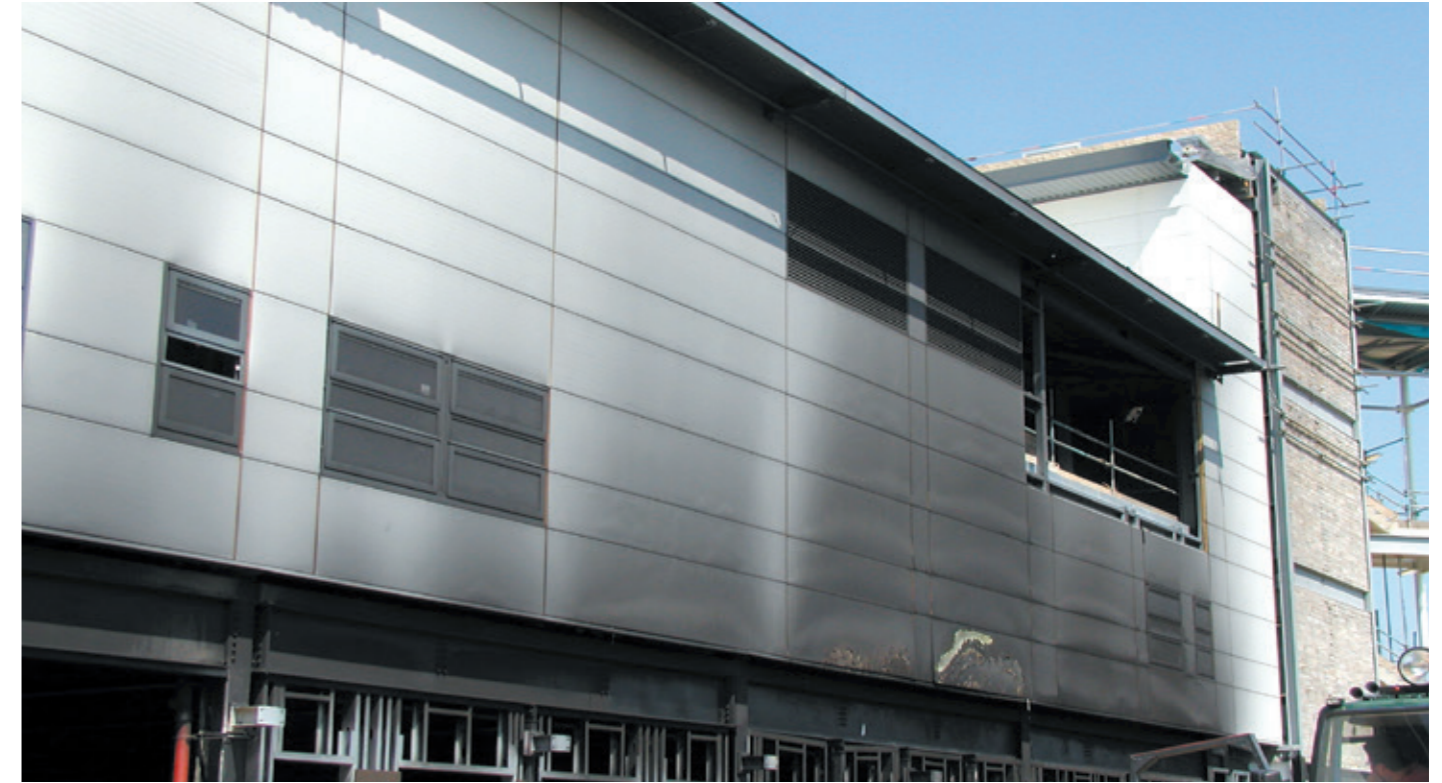
The main image above shows where the insulated cladding panels on the external face of the building had been attacked by flames.

A fire occurred at a hospital under construction during the summer of 2003. The building was steel framed with concrete floors. The first and second floors were clad with Kingspan PIR insulated panels approved by LPCB to EXT-B of LPS 1181 Part 1.

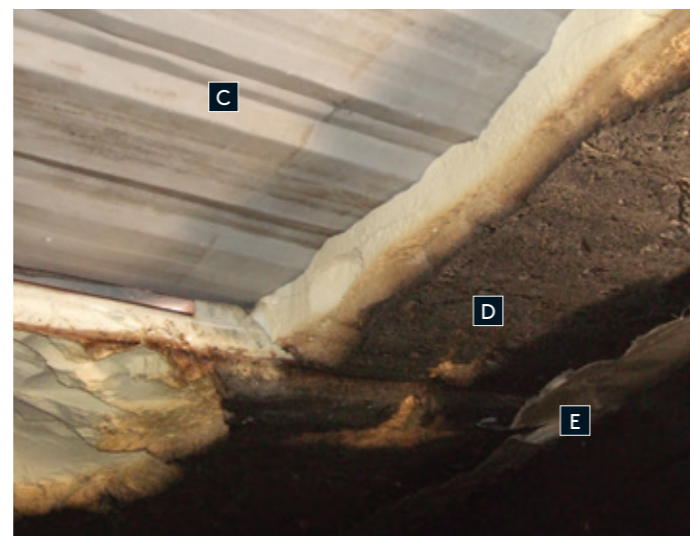
C: Temporary roof covering over hole in roof. D: PIR core showing delaminated lower surface and extent of through-thickness charring. E: Cut edge of lower steel skin of sandwich panel.

On locating the area of the fire the attending fire service cut a hole through the roof construction directly above the fire and in the location of the damage shown in the above image to ventilate the area. The images show the hole which was cut (which has been temporarily re-covered). The effect of the heat of the fire on the PIR core can be seen showing delamination of the exposed steel skin of the sandwich panel from the core, the formation of a carbon char layer and unaffected material at greater depth in the section which has been insulated from the fire.

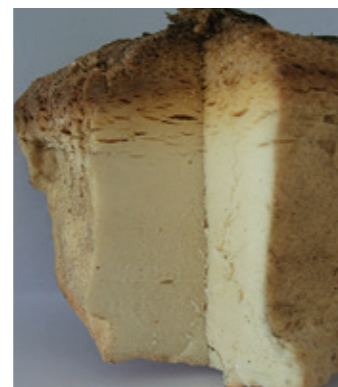
Insurer Approved PIR core sample showing extent of through-thickness charring at Suffolk Food Hall.

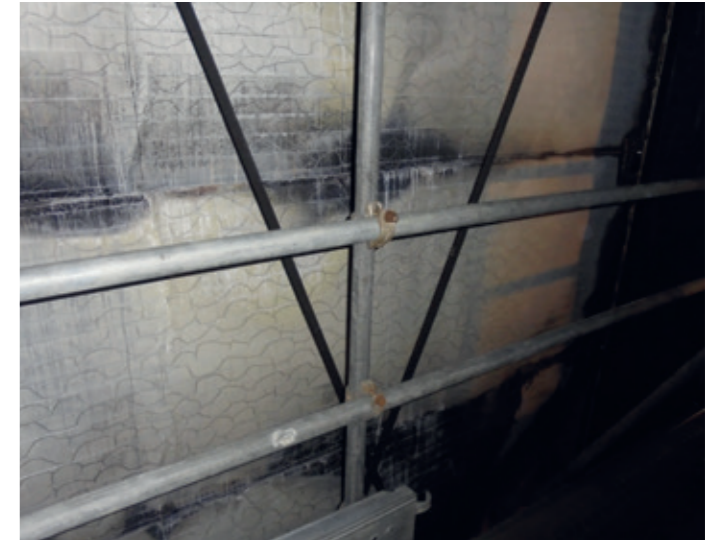
Panels exposed to fire internally.

Findings concluded that a fire emanated in the region of the base of the milk powder drying cyclone and the fluid bed dryer. It is in this area, approximately mid-way up the tower, that there is extensive fire damage to the plant and structure and where the cladding had been exposed to direct flame impingement. Here the fire has penetrated into the PIR core causing the material to surface char.

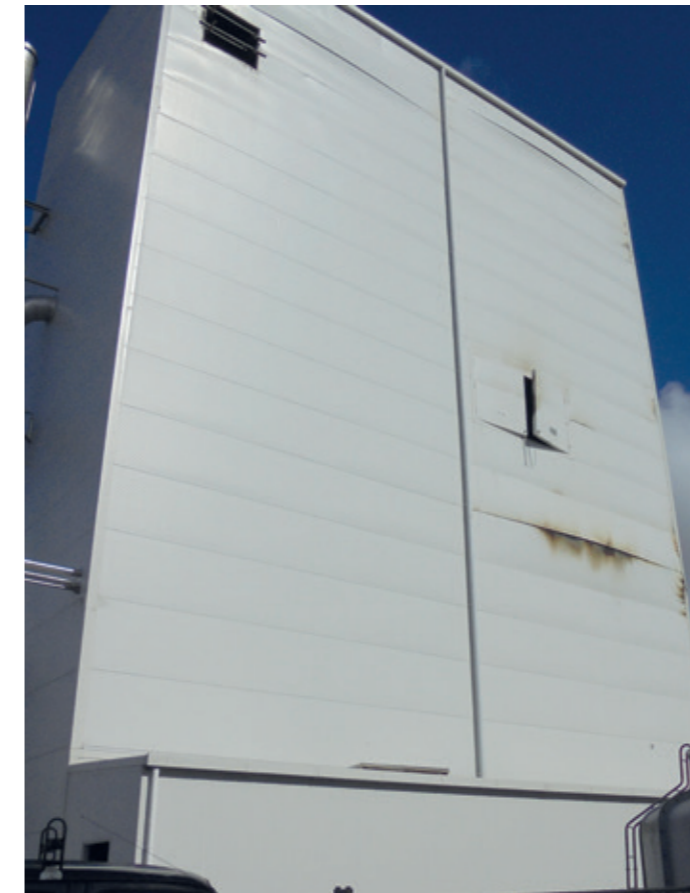
Milk powder drying tower showing external fire damage to panels explosion doors opened manually after fire).

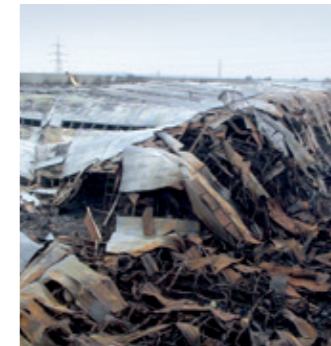
Collapsed south end of building.

The fire appeared to have started in the south end of the building which eventually collapsed. The fire burned for two days and two nights and it is clear from the photographs shown that the fire was very severe. Despite the duration and severity of the fire, significant areas of insulated cladding panels remained with only limited damage to core material indicating that the PIR core material did not promote fire spread.

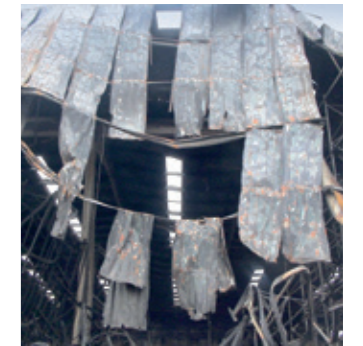
Roof sheeting hanging from severely deformed steelwork.

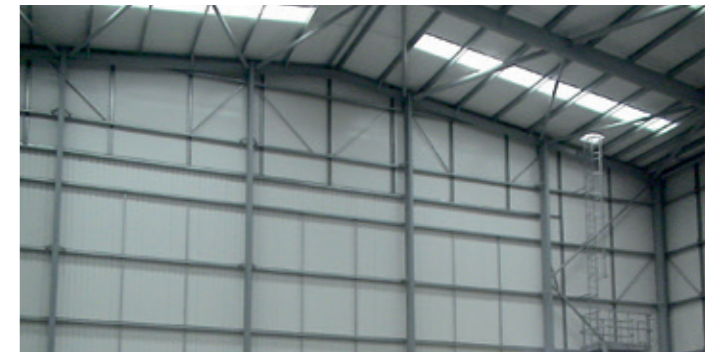
No heat transfer damage to interior of adjacent property.

The main image above shows north elevation of the adjacent building following the fire. The insulated cores of the panels did not ignite and did not transfer heat damage to the interior of the building.

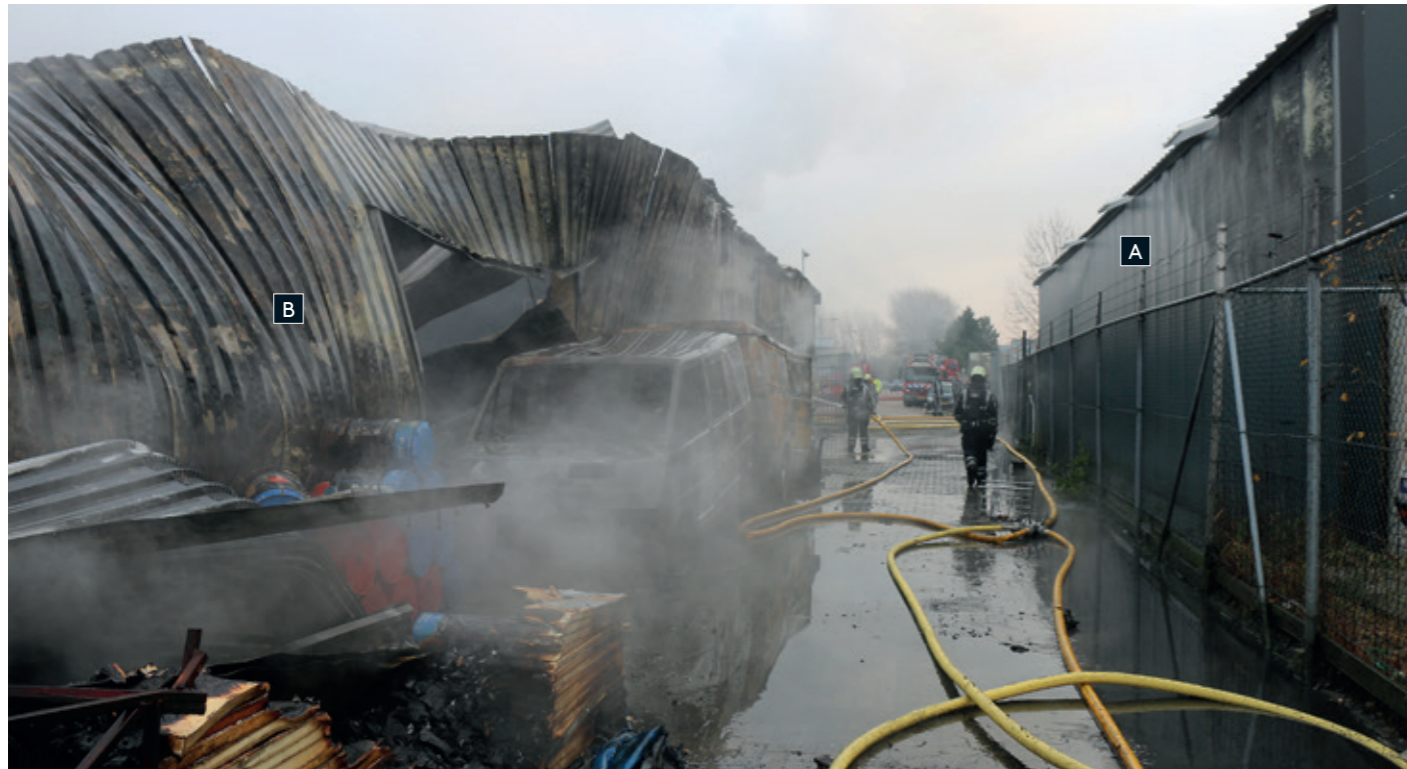
## Industrial Units, Heining, Netherlands

The site is on an industrial estate outside of Amsterdam and all the buildings involved in the fire were used by businesses carrying out automotive works and storing vehicles with associated equipment, parts and consumable materials.

The buildings of interest are the building clad with Kingspan FM / LPCB approved PIR core panels (A) and the building immediately adjacent which was destroyed by the fire (B). The former building measures approximately 31m long by 14m wide, with height of 4.5m to eaves and 6.5m to the ridge of its pitched roof. The latter building which was destroyed by the fire measured approximately 37m long by 16m wide and was about 4.5m high to its eaves.

- The fire in building B would have subjected the external façade of building A to levels of radiative heat flux sufficient to cause delamination of the PIR panels and charring of the PIR core.
- The level of fire damage actually sustained by the PIR core panels on building A indicates that the actions taken by firefighters to cool the external façade of building A using water jets had a significant effect in reducing the temperatures achieved by the exposed surfaces of the PIR panels.
- The behaviour of the PIR wall panels in this fire was commensurate with that observed in previous fire case studies.

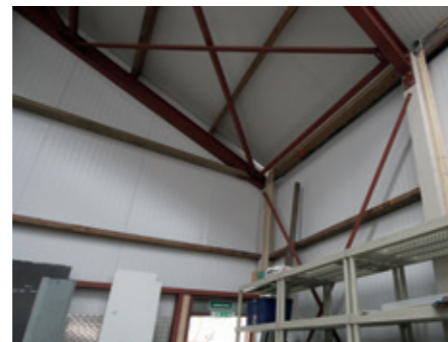
No heat transfer damage to interior of adjacent property (building A).

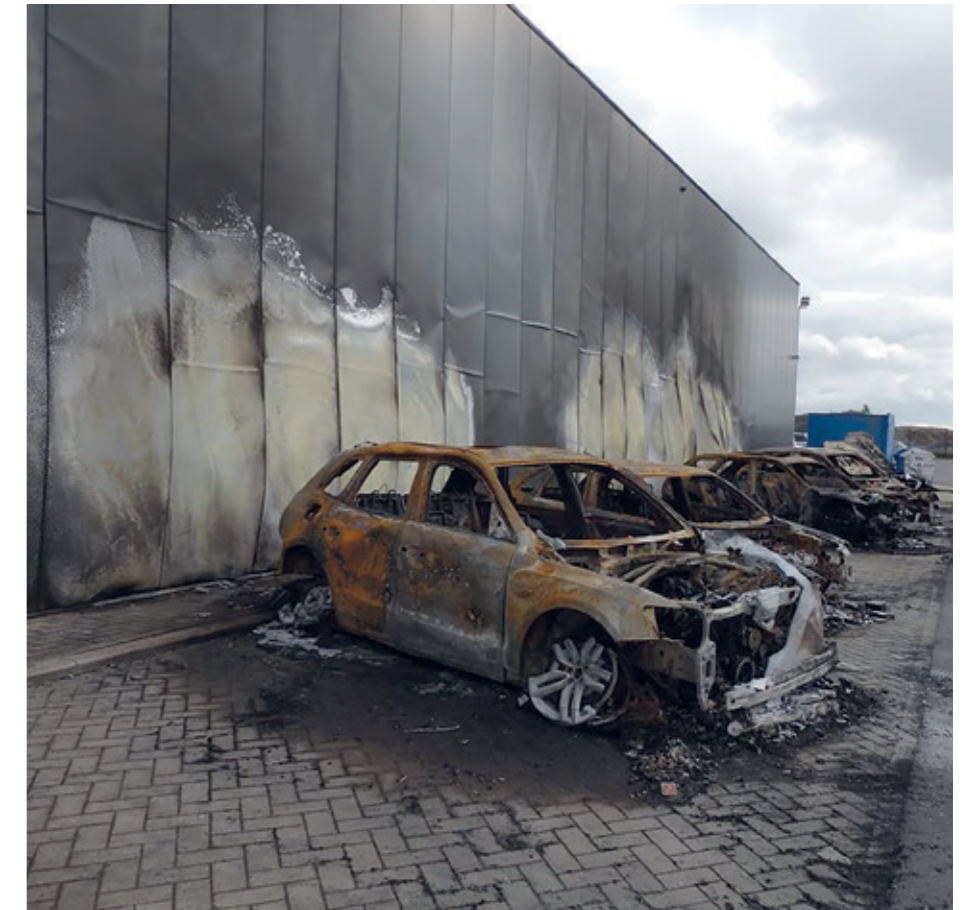
Photograph 1 shows the aftermath of the fire and is a photograph taken (by others) shortly after the fire event. The car in the foreground is understood to be an Audi Q3 with other cars being of at least a similar make and model.

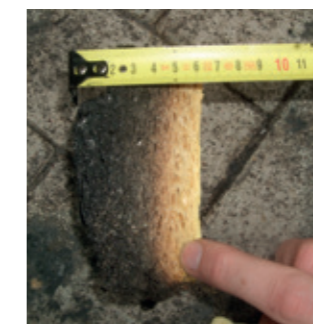
Photograph 2 shows a sample of the PIR core material removed from the ECOsafe PIR core panel at the location of predicted peak incident radiative heat flux of 31.8kW/m<sup>2</sup>. The photograph indicates that the PIR core had pyrolysed to a carbon char to a depth of about 40mm at this location. At locations remote from the area of peak incident radiative heat flux, the charring of the PIR core was significantly reduced, demonstrating that combustion had not been propagated by the PIR core material.

- The PIR cored sandwich panels were subject to a fire likely to have lasted at least 15 minutes from ignition.
- It is likely that the cladding will have been subjected to peak incident radiative heat flux of at least 31.8kW/m<sup>2</sup> for a period of at least 10 minutes.
- The sandwich panels exposed to these conditions sustained damage in terms of delamination of the exposed steel skin of the panels away from the PIR core, removal of the paint coating and pyrolysis of the PIR core material to a depth of approximately 40mm.
- There was no evidence of fire propagation within the panels.

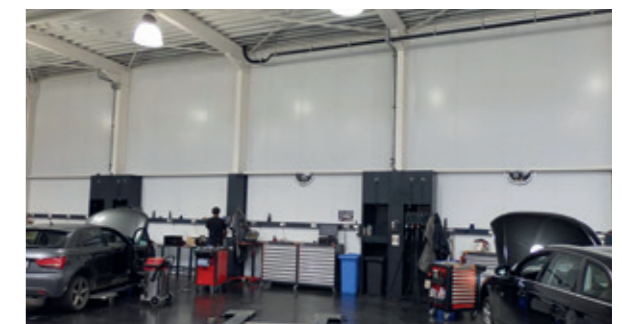
No evidence of fire penetration to interior of the workshop

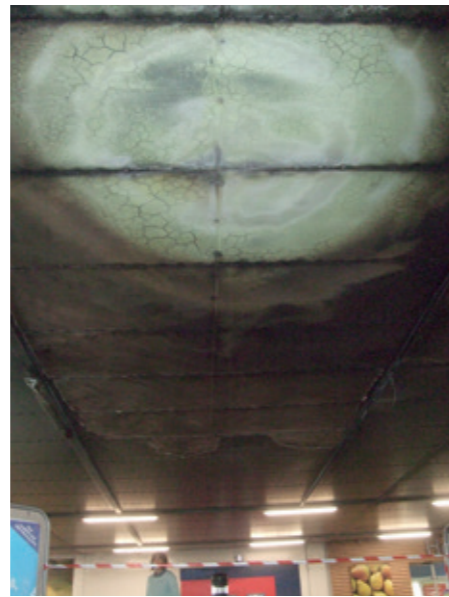
Evidence of direct flame impingement on soffit lining directly above the car.
